**Santa Monica Mountains National Recreation Area
Visitor Center, King Gillette Ranch**

Addenda #2 - April 8, 2009

INVENTORY AND CONDITION ASSESSMENT
BUILDING 8 - GILLETTE RANCH

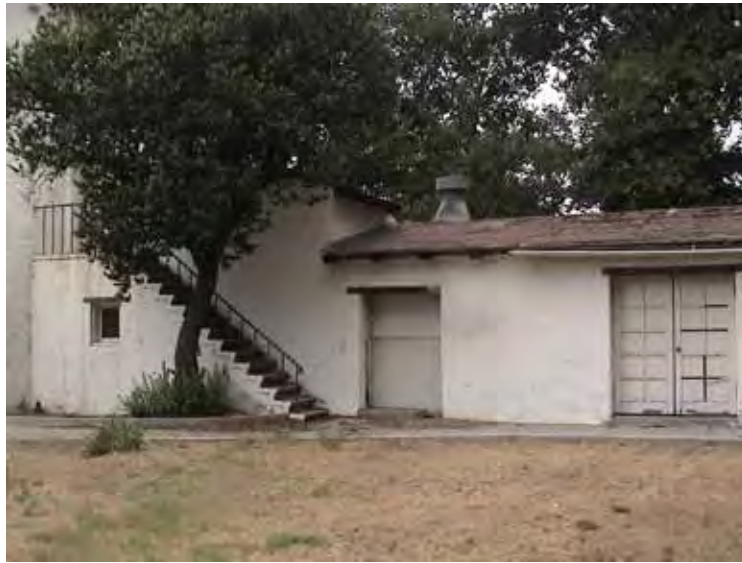
#2 – Exterior/ Damaged Roof

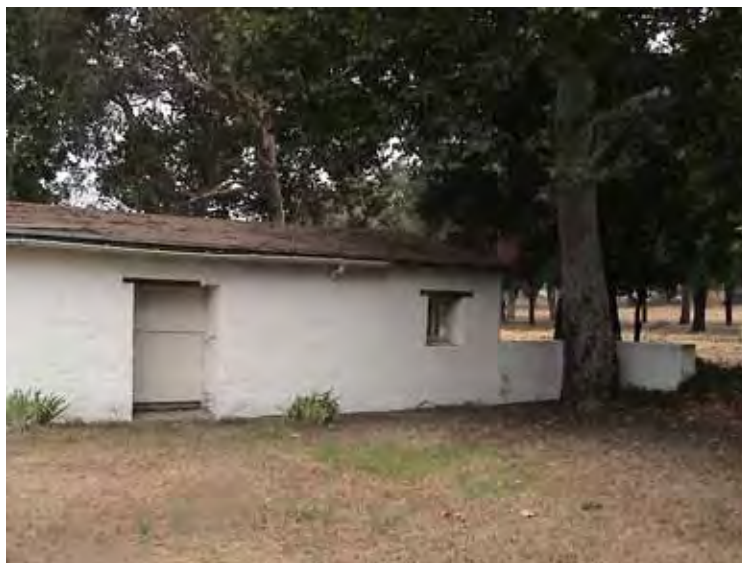
#3 – Exterior/Damaged Roof

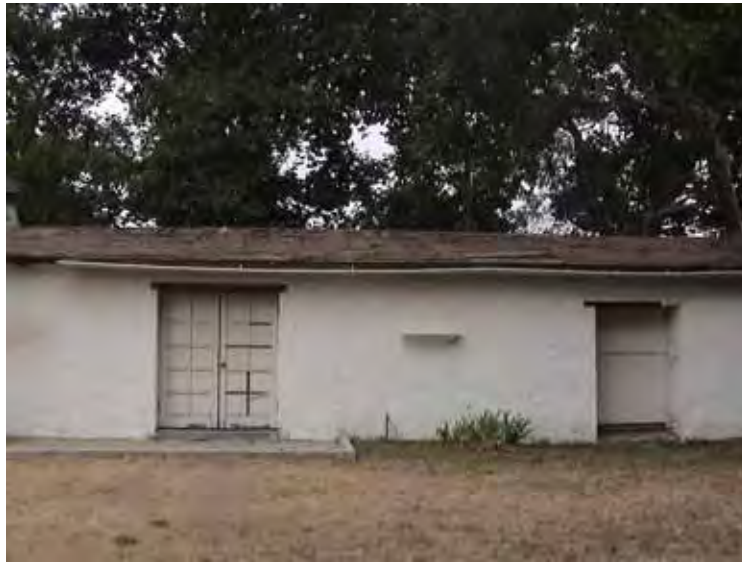
#3 – Exterior/ Damaged Lintel/ Damaged Roof

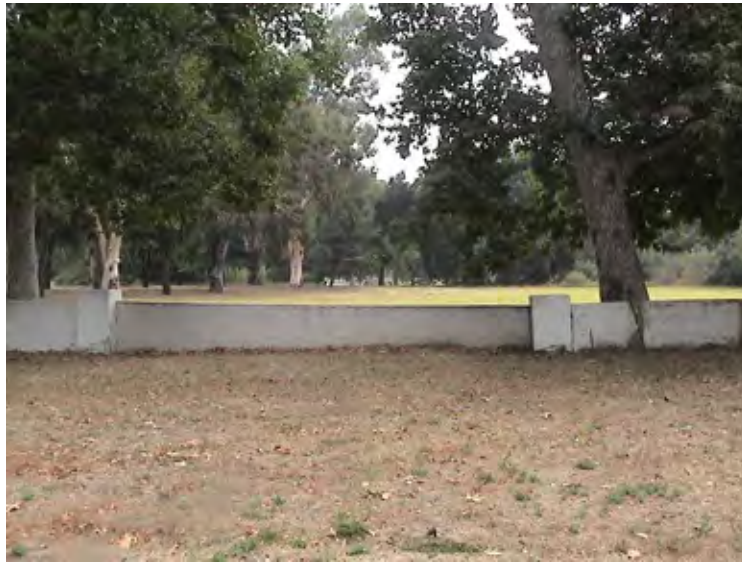
#7 – Exterior – Infilled Portion of Low Wall

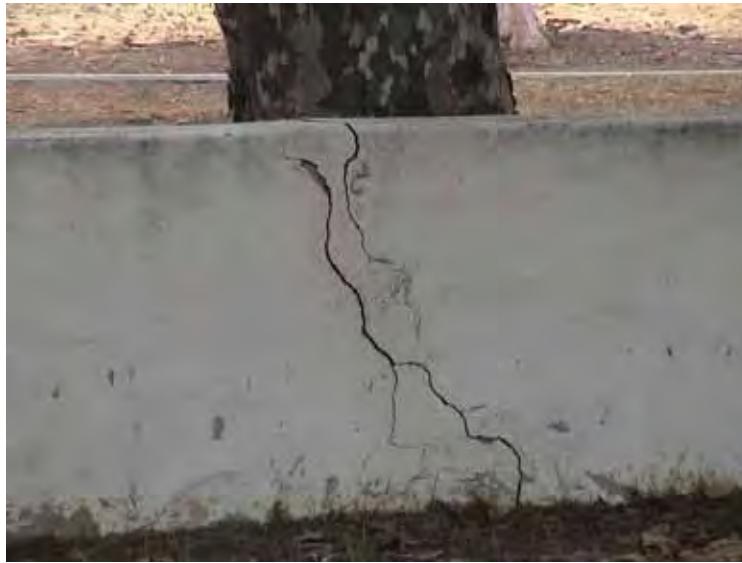
#9 – Crack in Low Wall

| Condition | Site walls around court on east side are cracked due to tree roots pushing up. |

| Corrective Action | Remove trees, which are planted too close to walls. Replace with new plantings separated from walls. Restore wall. |

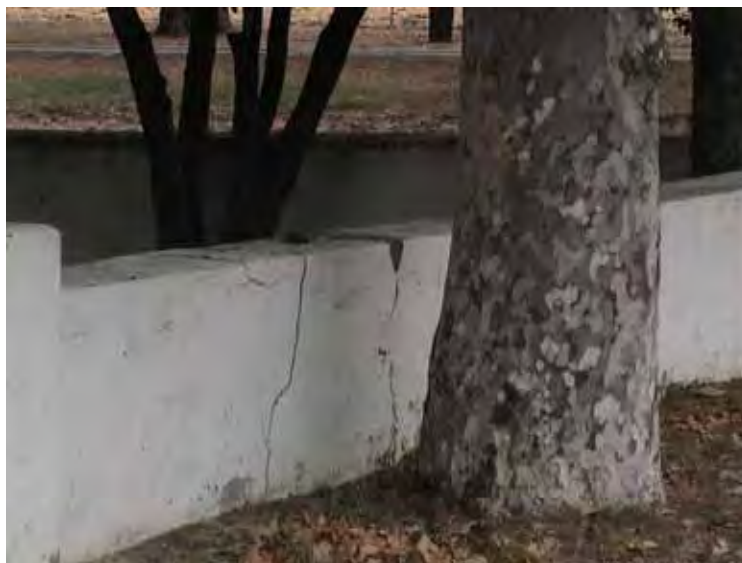
#10 – Crack in Low Wall

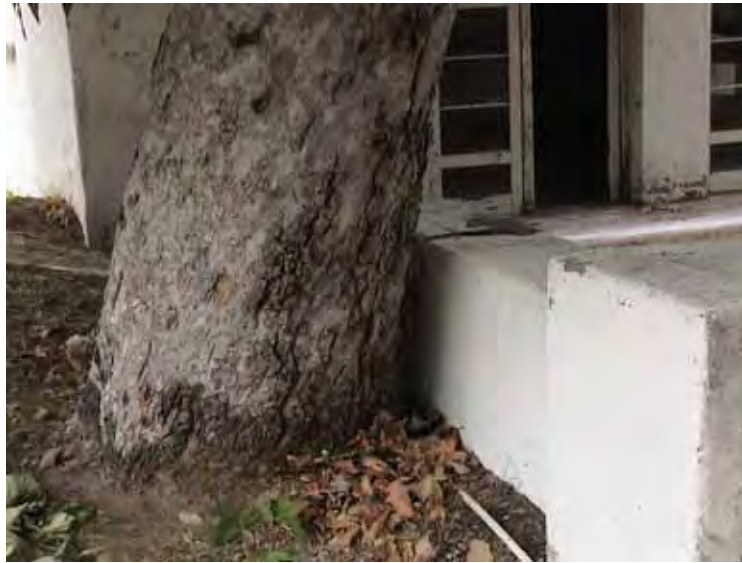
#11 – Crack/Breakage in Low Wall

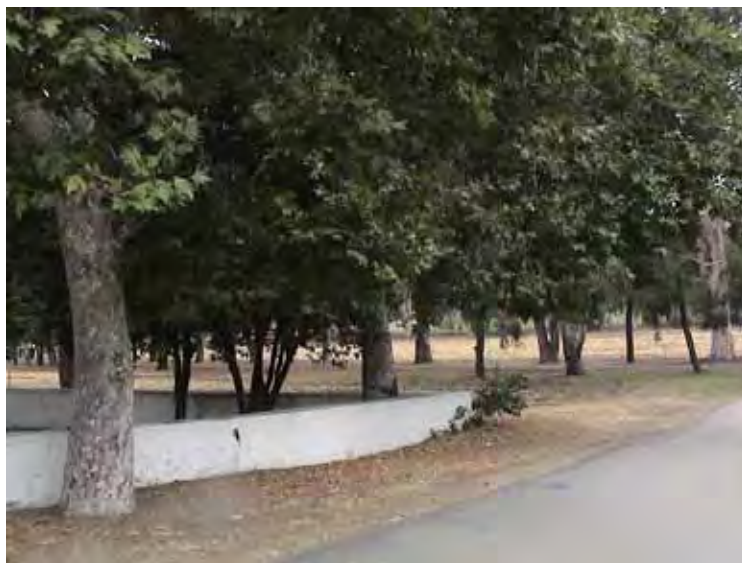
#12 – Cracks in Low Wall

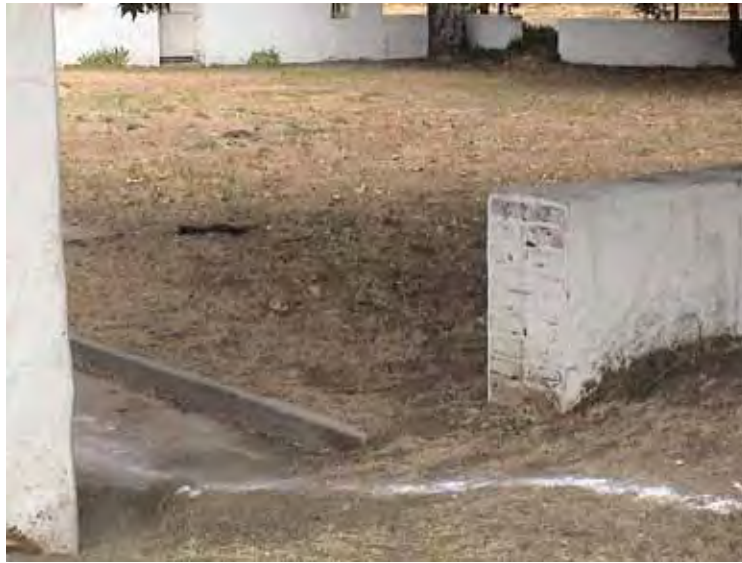
#13 – Exterior Drainage Issues

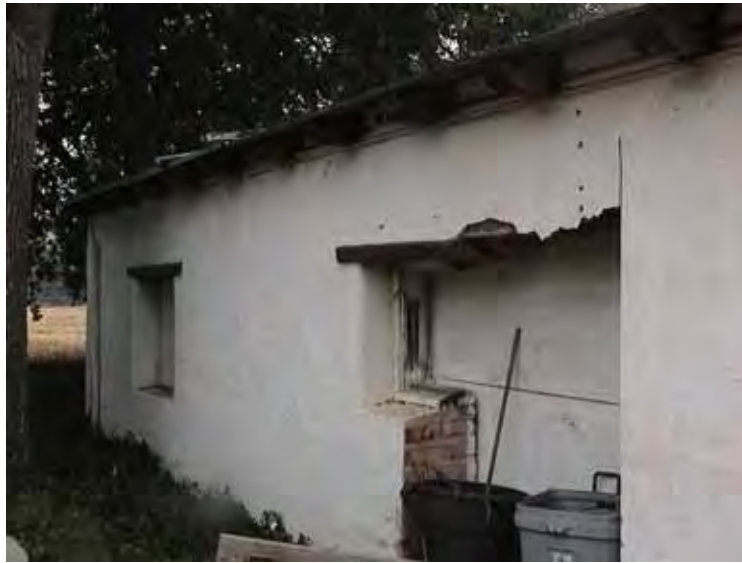
#20 – Exterior Wall Damage

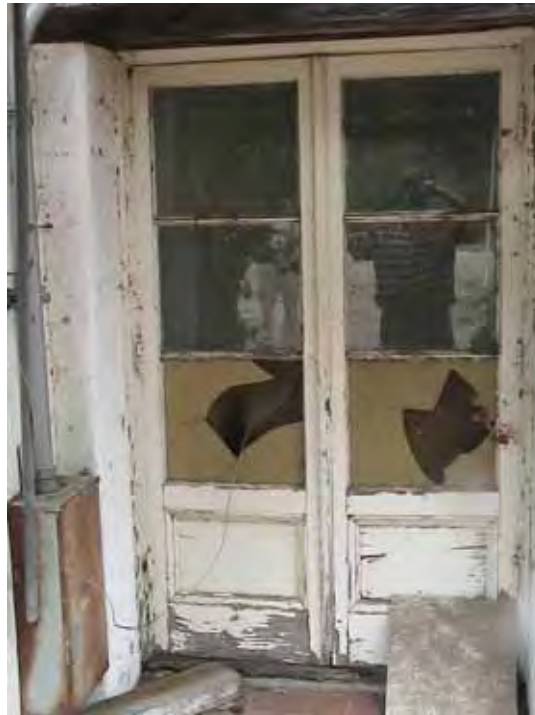
#21 – Exterior Door Damage

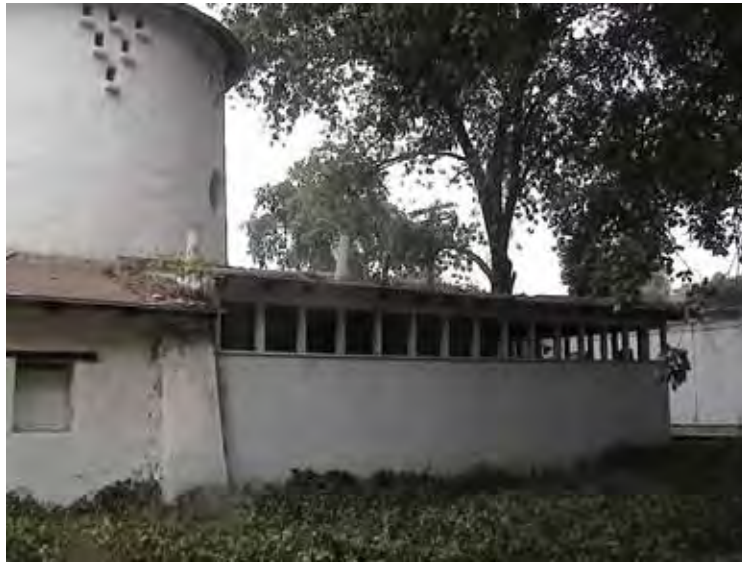
#23 – Exterior –Added Lean-to at West Corner

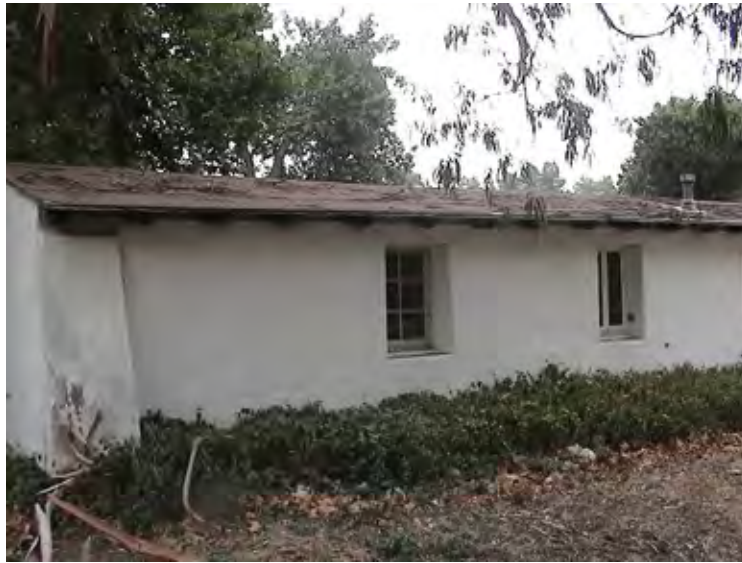
#25 – Exterior Roof and Plaster Damage

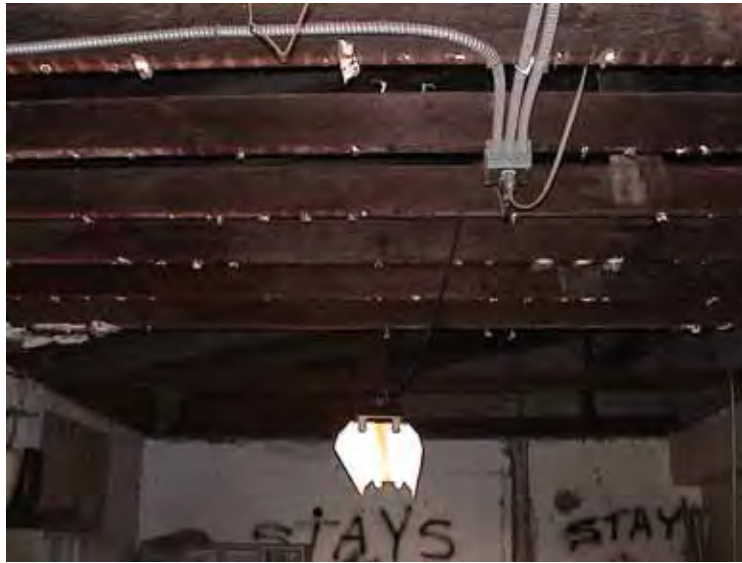
#27 – Exposed Ceiling Rafters

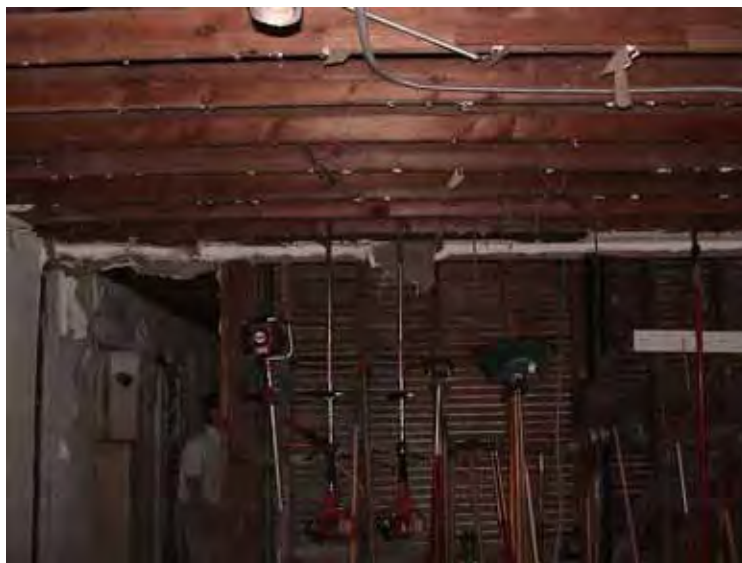
#28 – Exposed Wall and Ceiling Rafters

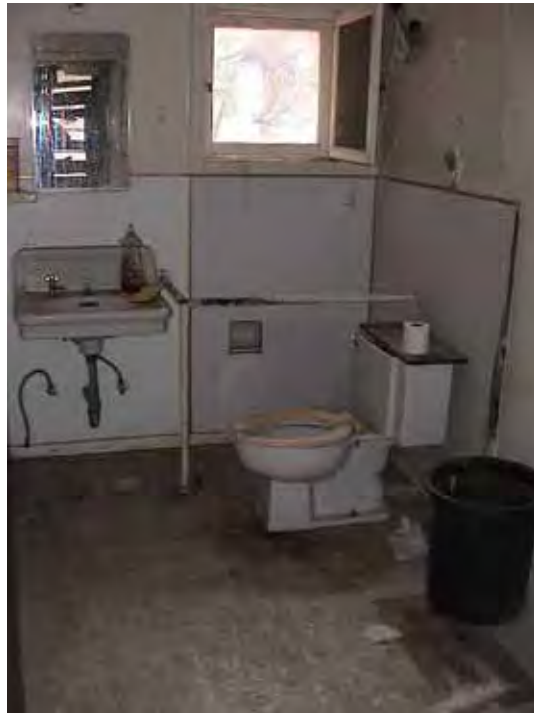
#29 – Damaged Plumbing Fixtures

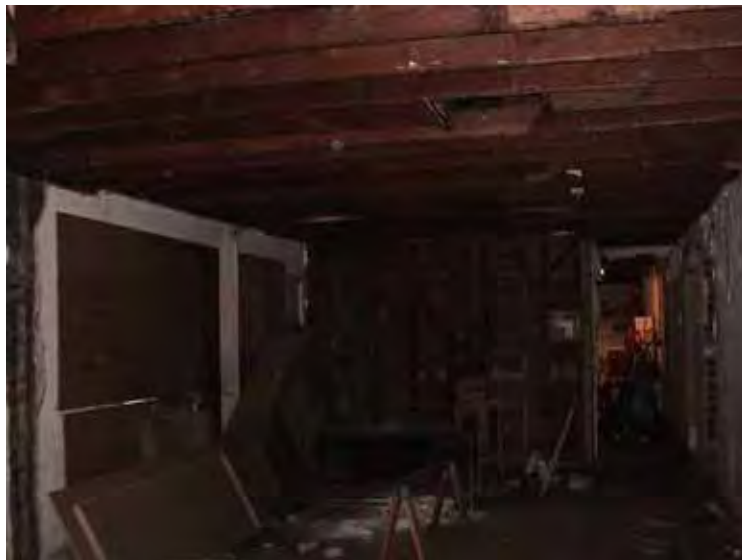
#30 – Exposed Walls and Ceiling Rafters

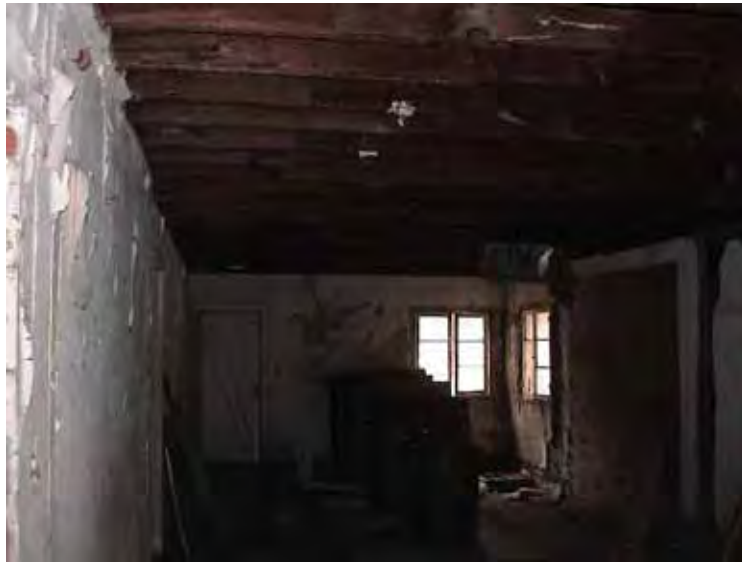
#31 – Exposed Ceiling Rafters and Plaster Wall Damage

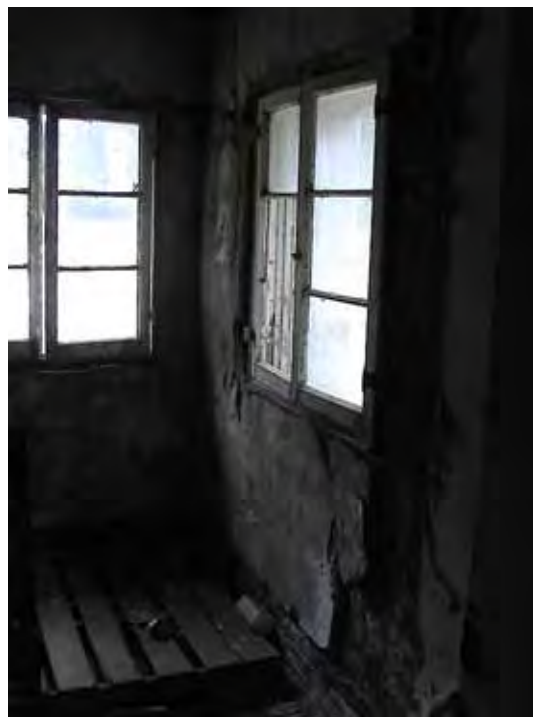
#32 – Plaster Wall Damage

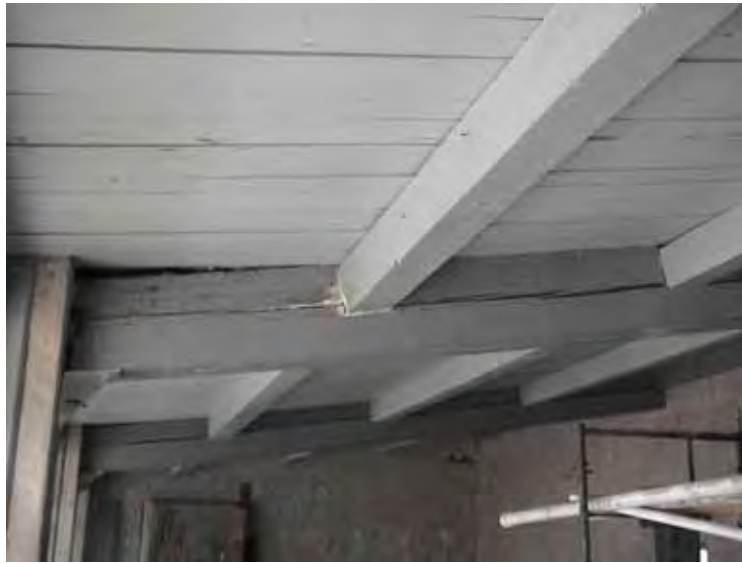
#33 – Roof Beam Damage-Beam shrunk away from roof sheathing

| Condition | Walls and bond beam in very good condition (where not cut into by abortive remodeling). Heavy timber beams in Southeast Wing rotted, split, shrunken away from roof sheathing and inadequately supported. Roof sheathing completely deteriorated. Timber beams in Northeast Wing in good condition (where not cut by abortive remodeling). Bearing wall removed in stables. Several door openings widened without extending or upsizing overhead wood lintel. Concrete lintels/bond beams cut. Opening cut in roof decking. Roof beams bearing on inadequate steel brackets. Roof beams decomposed at bearings on masonry wall – no moisture barrier at bearing points. |

| Corrective Action | <p>Requires comprehensive Structural retrofit, including new column-to-beam connections, new beams, new roof sheathing and possible retrofit of adoblar walls.</p> <p>Re-install missing walls – both stud and brick.</p> <p>Replace inadequate lintels or reduce door widths to original size.</p> <p>Form and re-pour damaged concrete lintels.</p> <p>Removed damaged roof decking and replace. Close additional roof openings.</p> <p>Replace roof beams with steel wide flange beams and clad in wood. Provide wind/seismic anchors at wall bearing.</p> <p>Replace damaged roof rafters.</p> <p>Insulate and re-roof entire area. Re-install clay tiles.</p> <p>Replace Juliette balcony floor blocks with P.T. lumber.</p> |

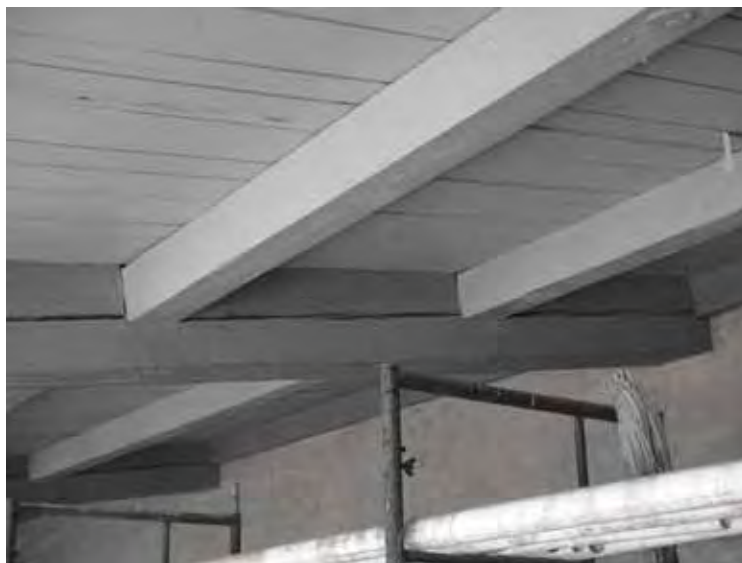
#34 – Room Beam Damage-Longitudinal split in beam

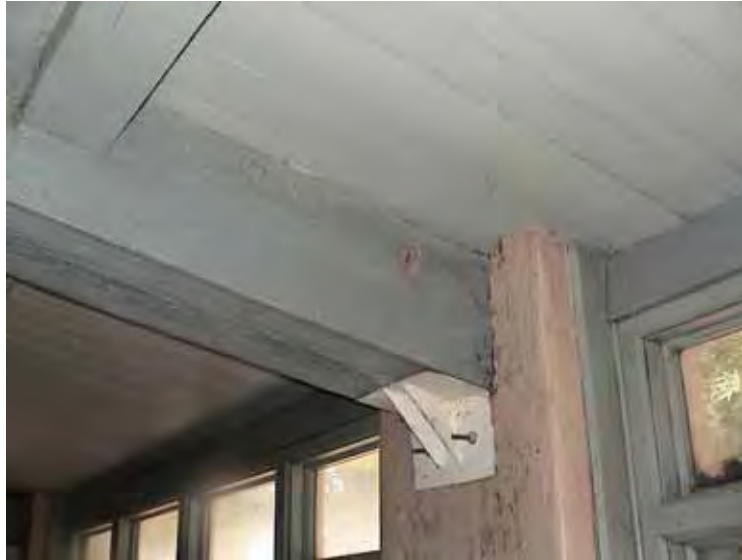
#35 – Room Beam and Support Damage

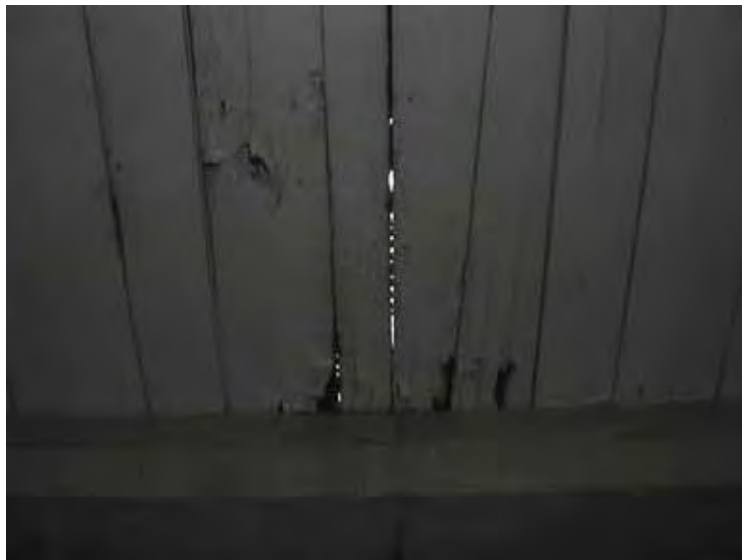
#36 – Daylight in Roof

| Condition | <p>Asphalt roll roofing disintegrating in certain area, particularly near perimeter, resulting in water penetration.</p> <p>Daylight visible in places between 1 x sheathing, which are rotted in places. (Photo #36)</p> <p>Several areas where the roof has completely been damaged so severely that it is total exposure to the outside. (Photos #45 and #46)</p> <p>Gutters are too damaged to function, or are or missing all together.</p> <p>Most of the original copper flashing at the juncture of the cylindrical Hay Loft volume with the gable roofs of the two wings is intact and functioning – is cracked in one location on the north.</p> |

| Corrective Action | <p>Once roof beams are re-built where required, replace roof sheathing, roofing membrane, and if design permits, barrel clay roof tile (or, alternatively, asphalt roll roofing).</p> <p>Repair copper flashing to blend with original.</p> |

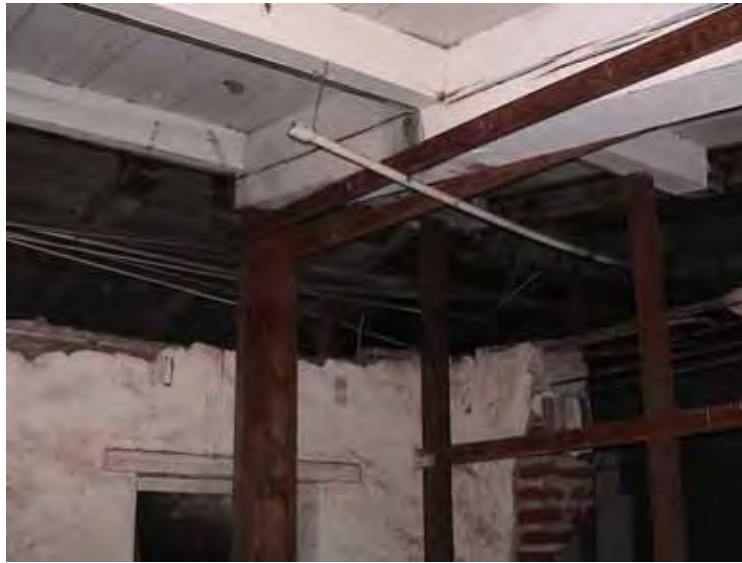
#37 – Roof Beam Damage-Partially removed beam, adoblar walls in background

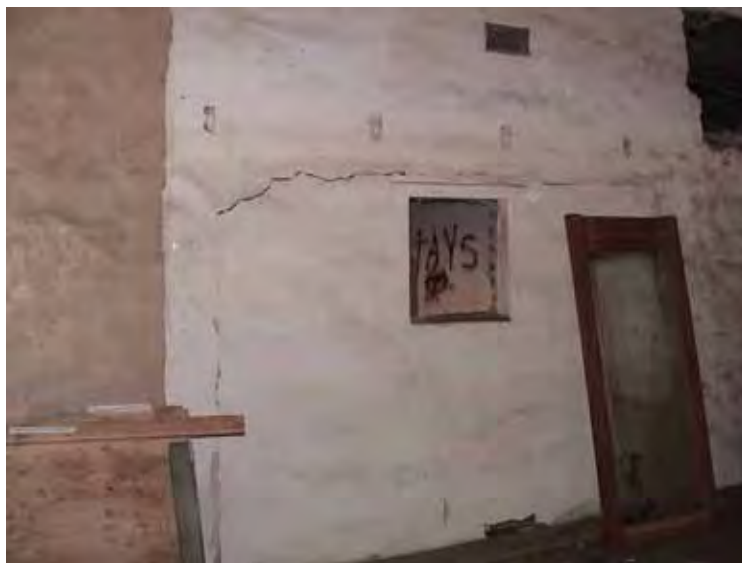
#38 – Cracks in Plaster Wall

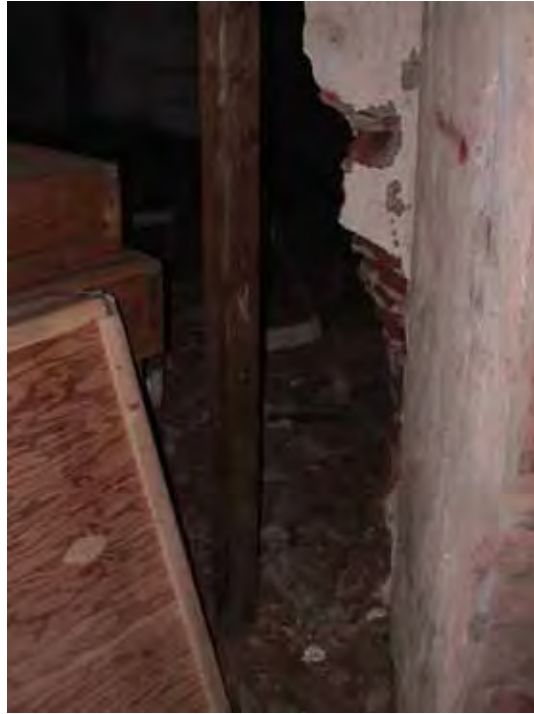
#39 – Damaged Wall and Unprotected Column

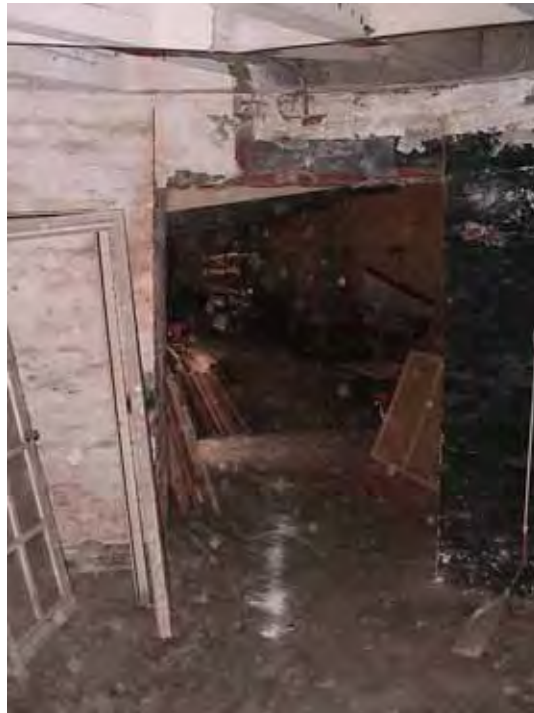
#40 – Wall Damage-Saw-cut opening under Hay Loft

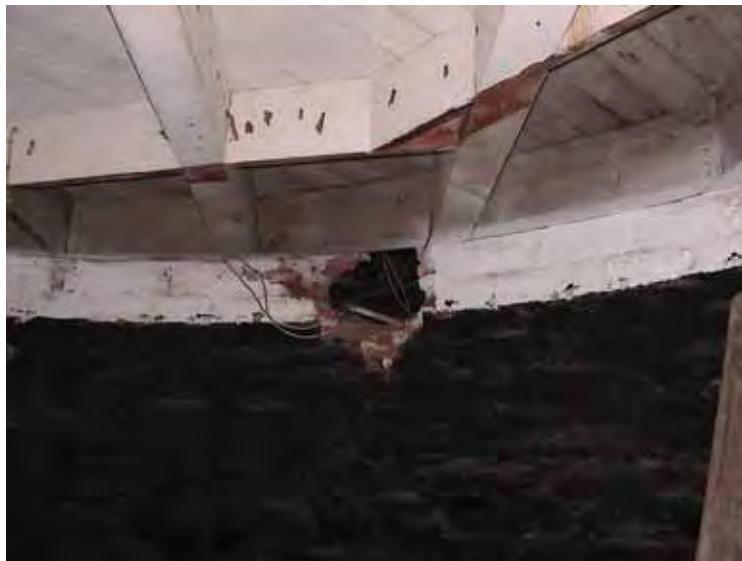
#42 – Hole/Damage in Wall

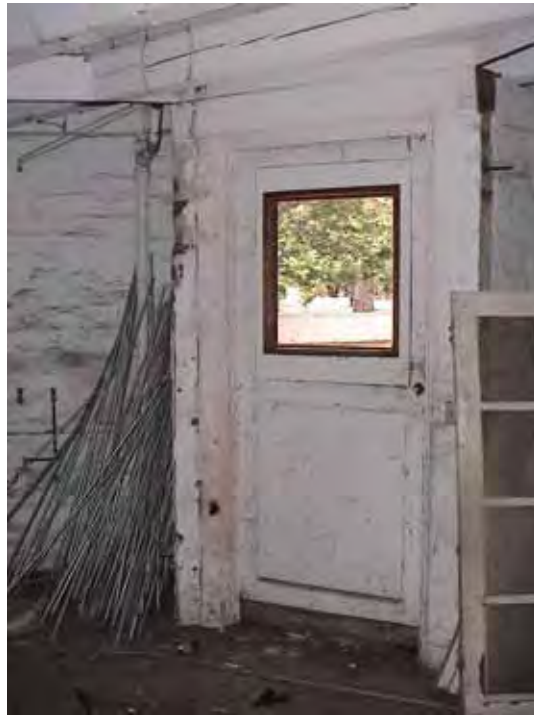
#43 – Damaged Door and Frame

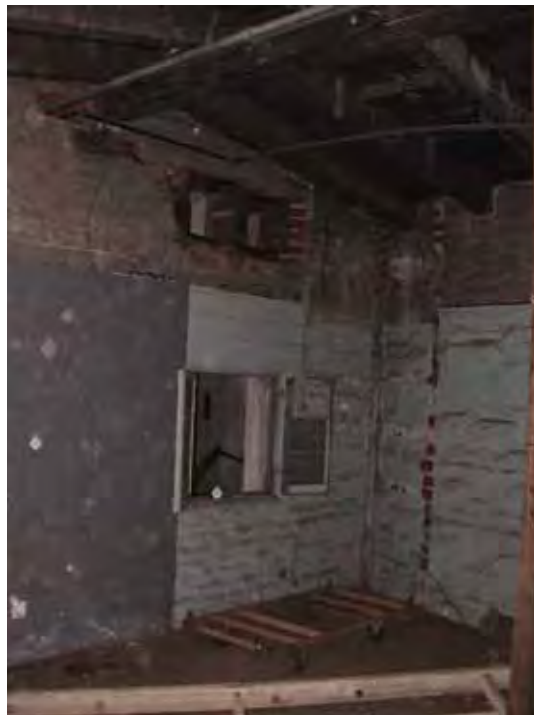
#44 – Damaged Walls

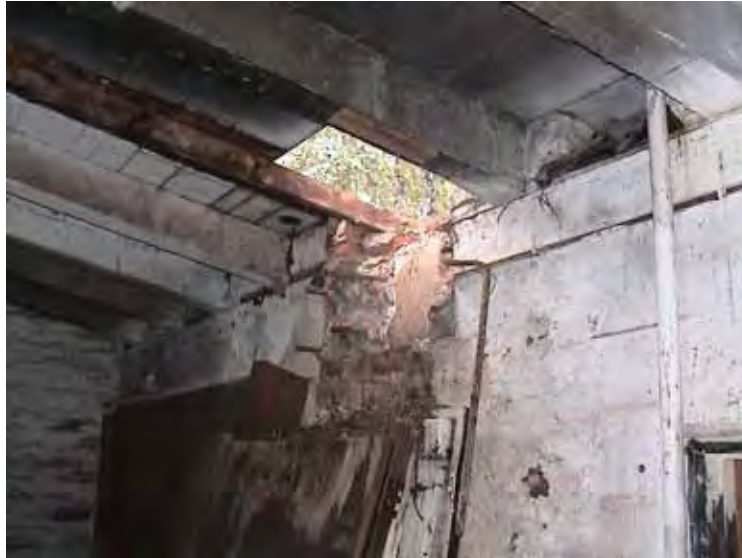
#45 – Hole in Roof/ Damage to Wall where Adoblar Wall Removed

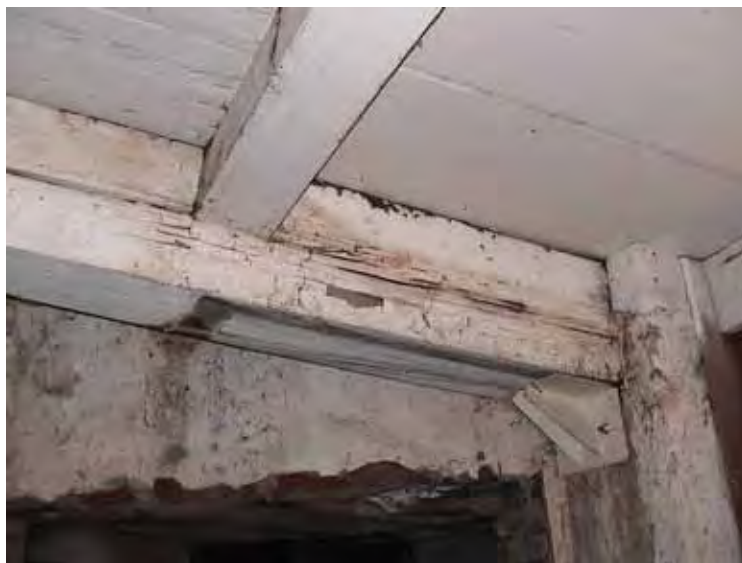
#50 – Damaged Roof Beam-Damaged adoblar wall beyond

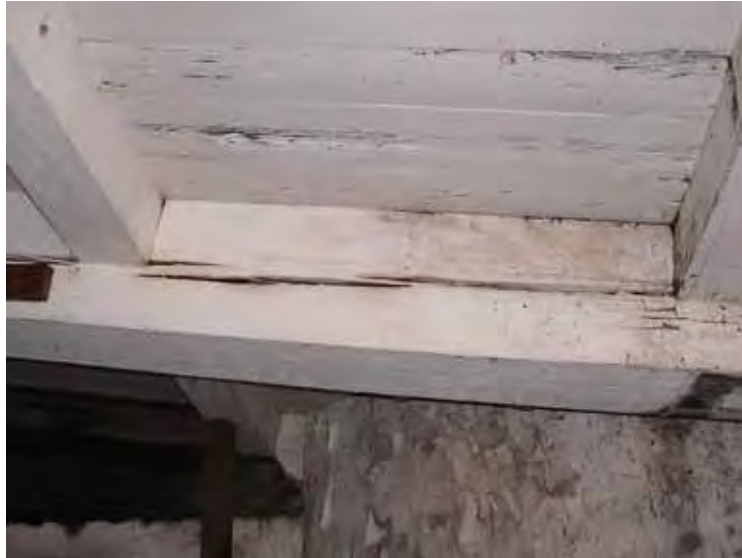
#51 – Damaged Roof Beam

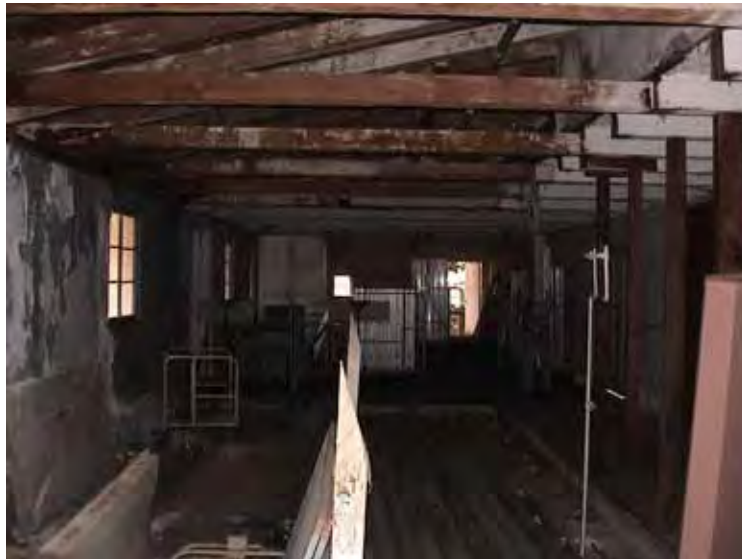
#52 – Exposed Ceiling Rafters Propped Up Where Wall Was Removed

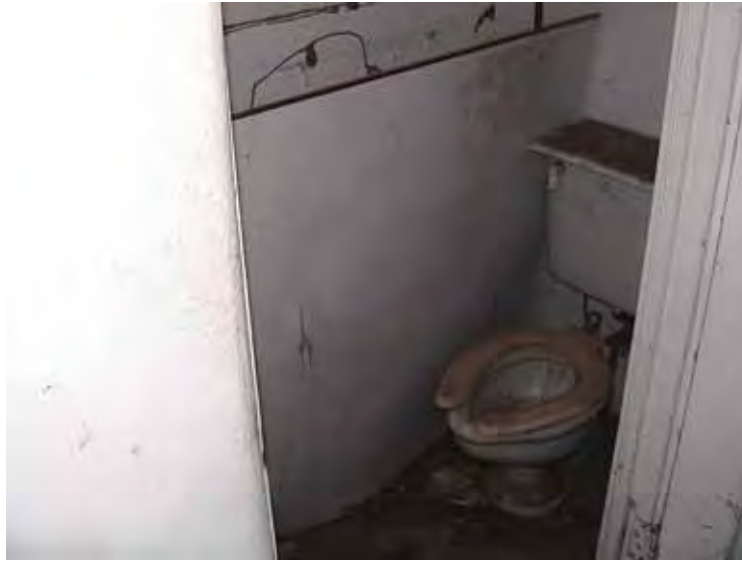
#52 – Damaged Plumbing Fixtures

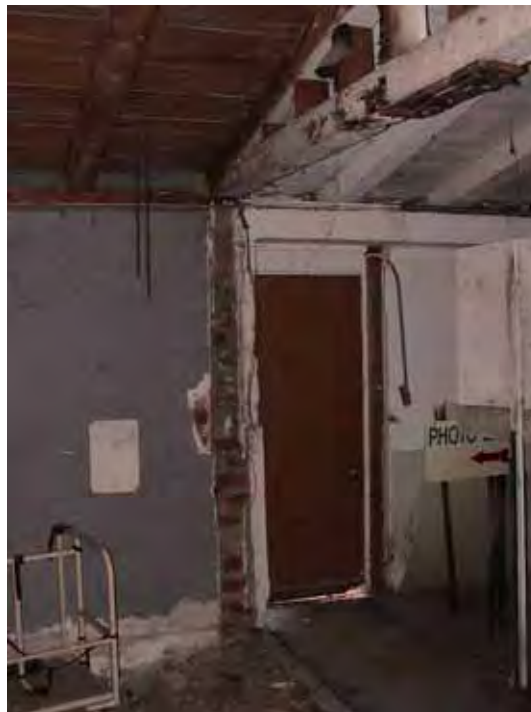
#53 – Damaged Walls, Door, Door Frame and Exposed Ceiling Rafters

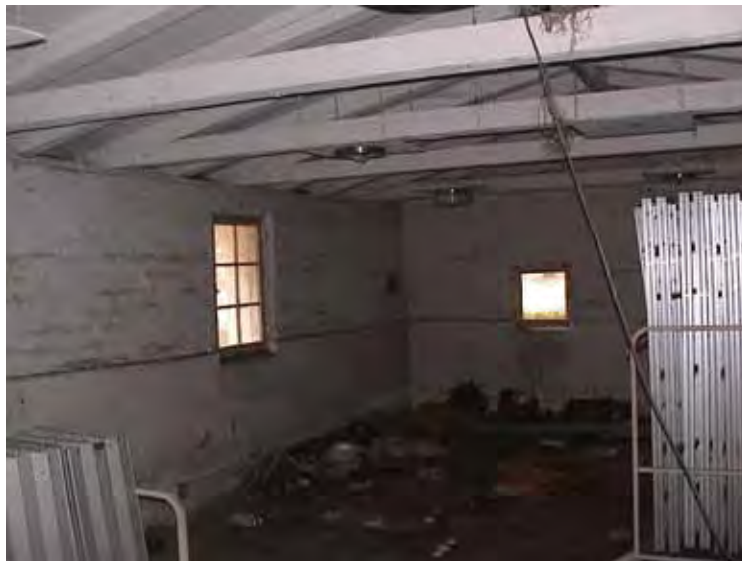
#55 – Exposed Ceiling Rafters and Plaster Wall Damage-Stables

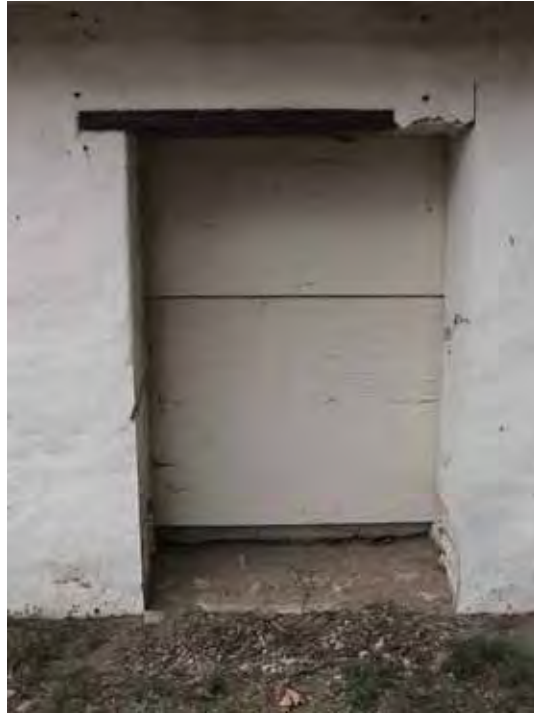
#60 – Damaged Lintel Beam

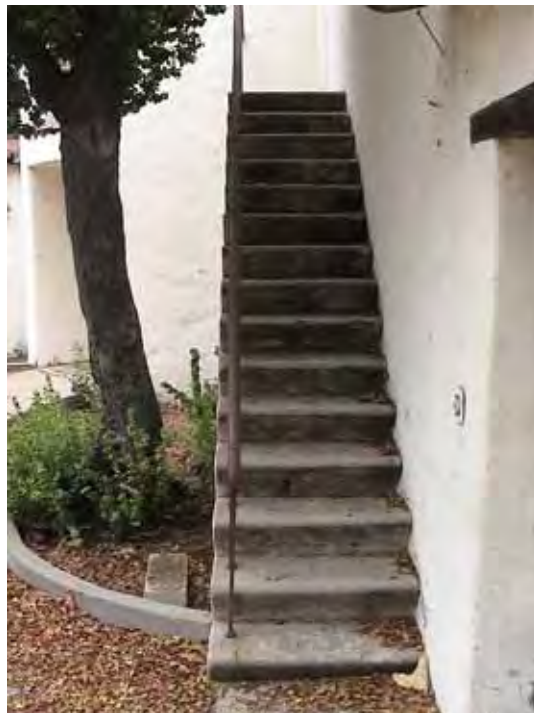
#61 – Non-Code Compliant Stairway in Good Physical Condition

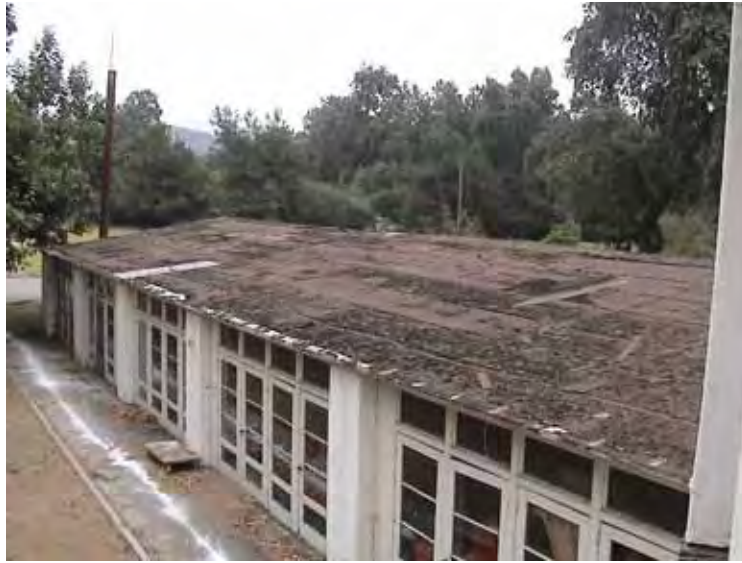
#62 – Damaged Roof

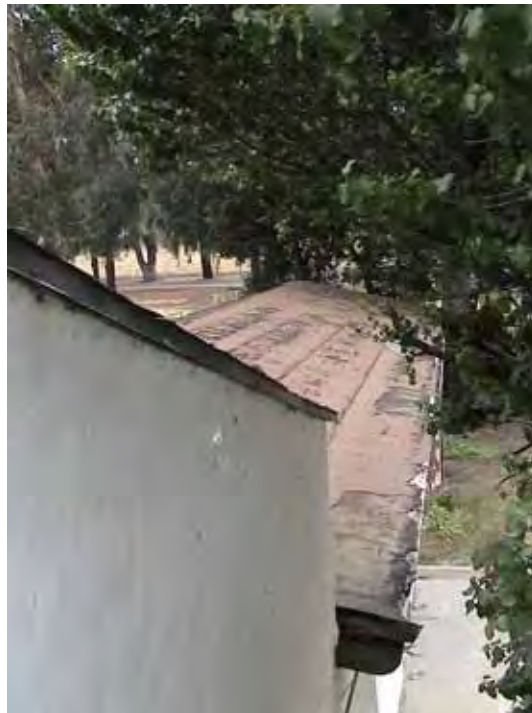
#63 – Damaged Roof

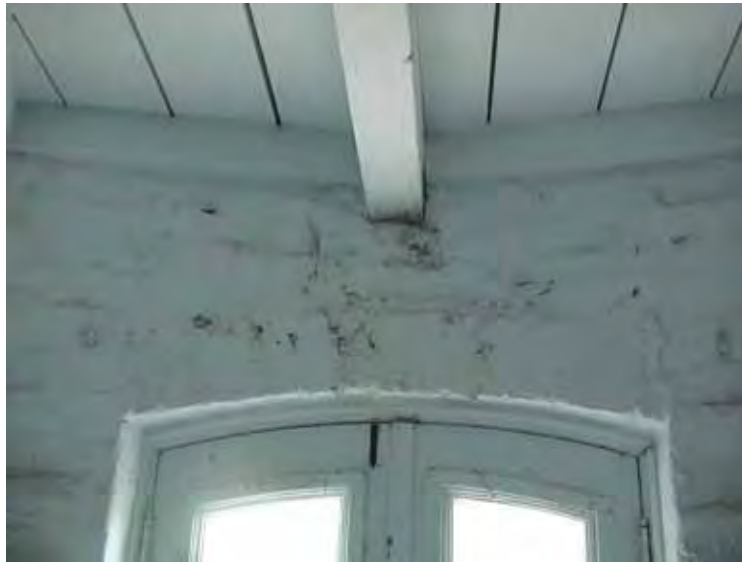
#64 – Water Damage in Wall of Hay Loft

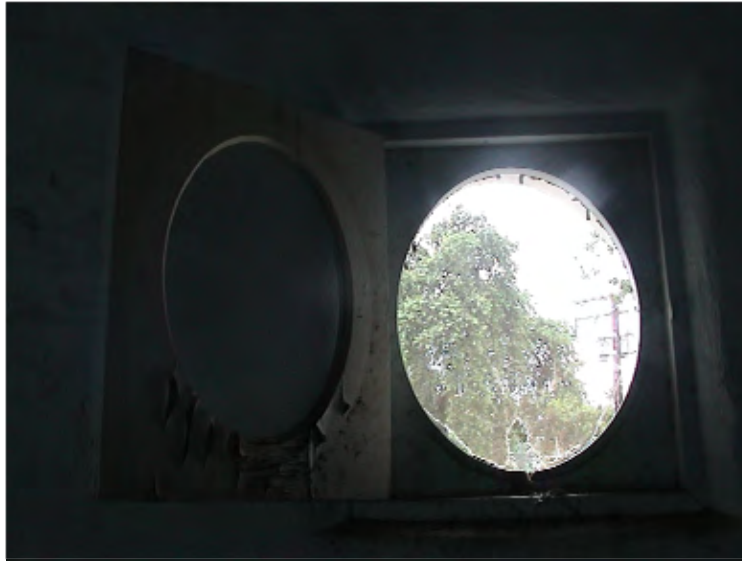
#70 – Water Damage to Window Frame and Wall
